CASE STUDY: PREMATURE WEARING OF THE OUTER PAD.

TECHNICAL

BULLETIN

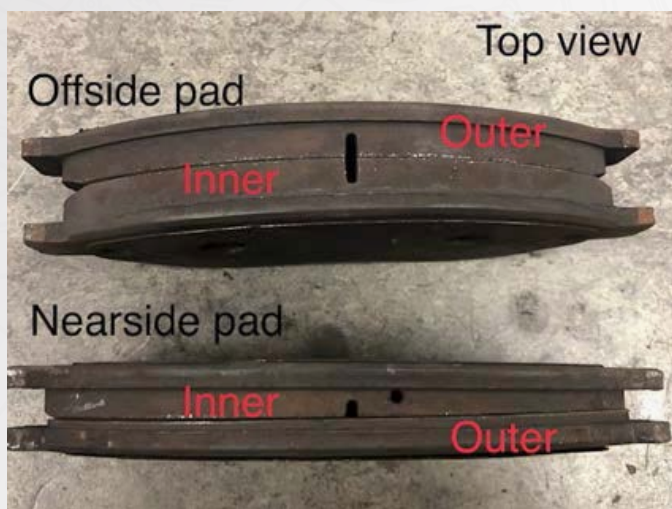
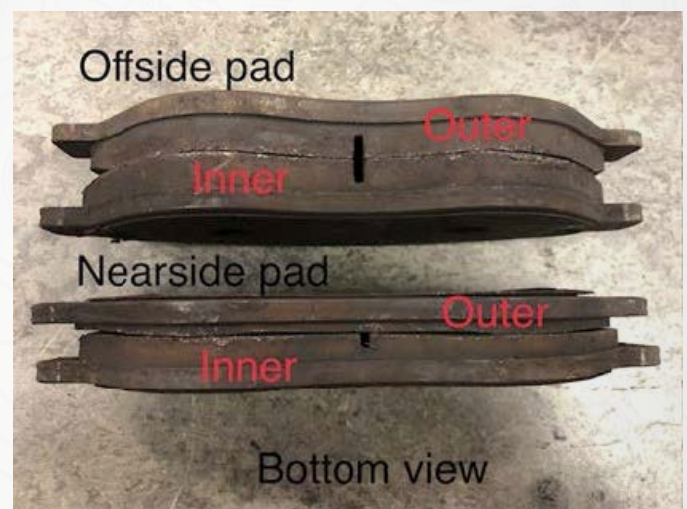
This issue had spanned over a few months. It had started with the owner of the vehicle purchasing the vehicle and requesting for the brakes to be replaced. A few months after the brakes were replaced the owner reported of squealing noises at low speeds as well as a burning smell. Upon removing the front discs and pads, they discovered that the NSF outer (or finger side pad) had worn down considerably more than the inner pad.

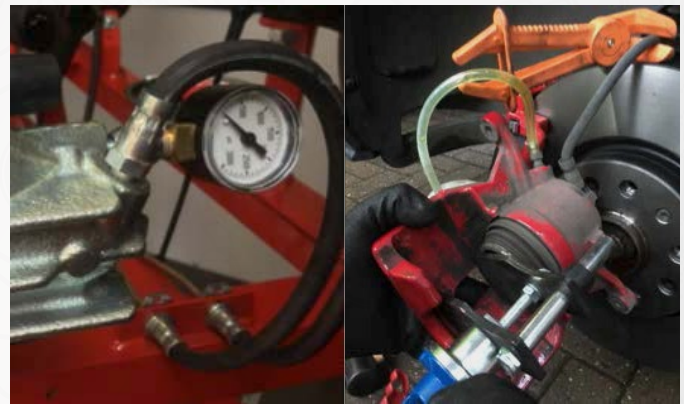
However, to ensure that there is no issue with residual hydraulic pressure causing the caliper to bind, a hydraulic pressure gauge was attached to the caliper to confirm this. With the gauge attached, without any pressure on the brake pedal, no pressure will be recorded on the gauge. To ensure that the caliper pistons are moving freely, hydraulic pressure was blocked to the caliper by clamping the brake hose followed by pushing the pistons back into the caliper with the bleed nipple undone. The brake fluid expelled can then be examined to ensure its condition and eliminate it from being contaminated to cause the piston to seize. The caliper pistons retracted easily indicating that the pistons will move freely without any obstruction. The brake fluid expelled wasn't contaminated and this proves that the brake fluid wasn't causing the pistons to seize. With the caliper removed, the brake pads were moving freely in the carrier and there was enough lubrication to assist with movement of the pads. The sliders were moving and had abundant lubrication to assist with movement.

As all components have been proven to move freely when disconnected from each other, TechMate suspected the possibility of a component that could be misaligned. Due to this misalignment, it would prevent the outer pad from returning. To confirm that the brake disc is in alignment, a run out measurement was taken to eliminate the brake disc as a source of misalignment. For this vehicle, the manufacturer's recommended maximum amount of tolerance for brake disc runout is 0.05mm. The runout reading was 0.04mm which eliminates the brake disc.

The other source of misalignment is the brake carrier, should this be misaligned, would be positioned in an angle that would prevent the outer brake pad from returning. To confirm this, a feeler gauge was used to measure the gap between the disc and the carrier and

compared the differences between the nearside and offside. By measuring, this confirms that there is a definite difference in measurement between the two. With the caliper bolted on to further confirm the misalignment, the nearside caliper kicks out slightly indicating a misalignment rather than moving laterally when the brakes are applied.

The carrier was replaced curing this issue and TechMate was delighted to have assisted to resolve the issue. If you ever have any questions, please feel free to contact our technical helpline on 01174 288100.
