A Ford Focus with unusual fuel trims

Tim Stock,
Autobiz Helpline

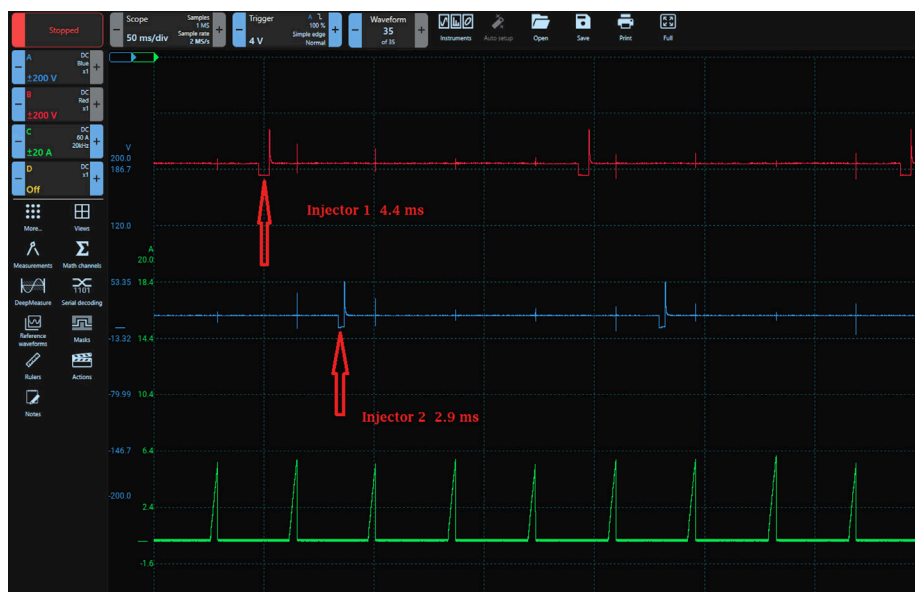
phase, all signals were as expected: coil current even across all cylinder firing, and injector pulse settled to 4.4 milliseconds, with no apparent misfire counters. When the misfire counters in serial data began to increase on both cylinders 2 and 3, the injector pulse on these cylinders began to decrease, and stopped at 2.9 milliseconds.

A scope trace showed the injector firing times were shorter for cylinders 2 and 3 when the engine was at operating temperature

The long term fuel trim (LTFT) indicated a decrease of 14%, even though the upstream lambda sensor was switching perfectly, the rear sensor output was 700mV.
