# A heavily smoking Mercedes C350e

An Autobiz Helpline member, had a 2014 Mercedes C350e in their workshop, suffering with excessive smoke from the exhaust.

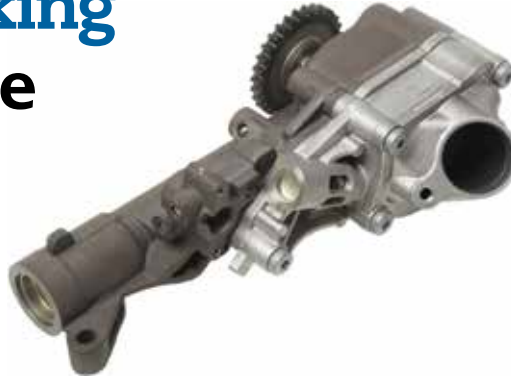
Within a few hours, the customer was back in the workshop with the same symptoms. A deeper look into the scan data revealed rather higher than normal oil pressure. From cold, the pressure exceeded 9.5 bar, far above the specified pressure.

**This Mercedes is now awaiting the modified part that is on backorder**

After this repair, the vehicle was rechecked from cold for the correct oil system pressure. But the pressure was still far too high on cold start. The expected idle pressure is 2 bar, rising to 4 bar under full engine load.

We decided to replace the oil pump. On contacting the dealer to order the pump, we were told this pump had been superseded, and the modified part is on backorder. Surprisingly, this one dealer had sold 20 of these oil pumps in just over 2 months.

Confident in the final diagnosis of a failed oil pump, this Mercedes is now awaiting the modified part that is on backorder.
