BMW 3 Series - ABS fault concerns

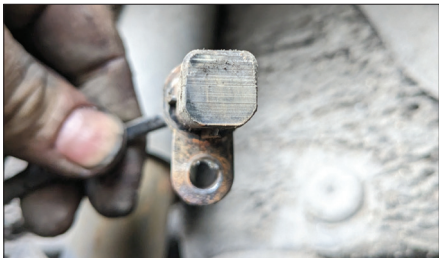
The expanded reluctor ring had worn into the road speed sensor, causing the ABS fault

We all know the wide range of faults that can be the cause of ABS failure. Common issues are a failed sensor, or a corroded reluctor ring. On this BMW, the fault was a combination of both problems. The reluctor ring had corroded and expanded. Then the expanded metal ring had worn through the wheel speed sensor.

A new reluctor ring and sensor was needed, and the driveshaft needed to be removed to carry this job out. Once removed, the driveshaft could then be cleaned up to accommodate the new reluctor ring.

Once all back together, and the system cleared of the fault codes, the BMW was given a quick drive to ensure that all was now well, and that the ABS was operating correctly again.
