BMW X5 - Twin turbo partial failure

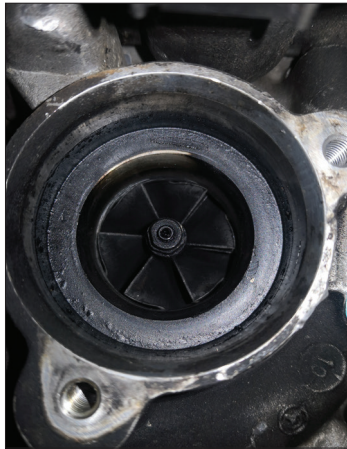
The smaller turbo (the high pressure one) on this BMW had failed, this is the one which is used to supply the lower engine torque. The larger, low pressure turbocharger, was still working, but the total

The smaller, high pressure turbo was easier to replace than the larger, low pressure turbo

failure of the high pressure turbo would have soon put paid to that.

The new turbo was fitted, along with the oil feed pipe, and the oil return was also checked to ensure this was clear. The X5 was then given a quick run in a very quiet area, to clear the exhaust before returning it to the owner.
