Going in deep to diagnose a Kuga wheel speed sensor fault

The Helpline recently received a call regarding an issue with an ABS fault on a 2010 Ford Kuga 2.0TDCi. The Kuga had a fault code recorded of C1144 - Tone ring missing tooth. The technician, being very experienced, followed the usual process of confirming, testing and then repairing.

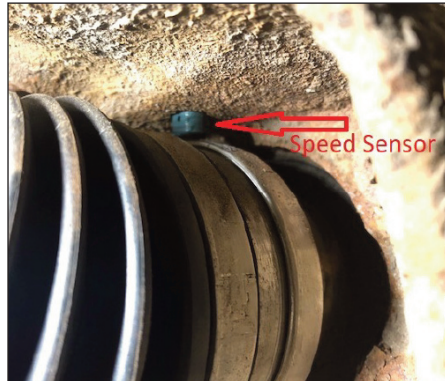
The wheel speed sensor was positioned over the axle shaft

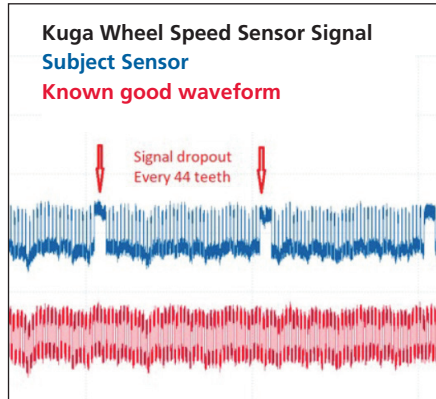
The first step was to use his Picoscope to see the signals from both rear speed sensors. This showed the tech an obvious signal error from the right rear wheel speed sensor. The signal showed a cyclic drop in the signal every 44 teeth. As the Tone ring is enclosed, no visible inspection was possible. The technician fitted a

A signal dropout at every 44 teeth suggested a broken tooth

new drive shaft, as this was the obvious answer. Unfortunately, it did not resolve the issue and the signal still showed a cyclic dropout ever 44 teeth. It was time for a closer inspection.

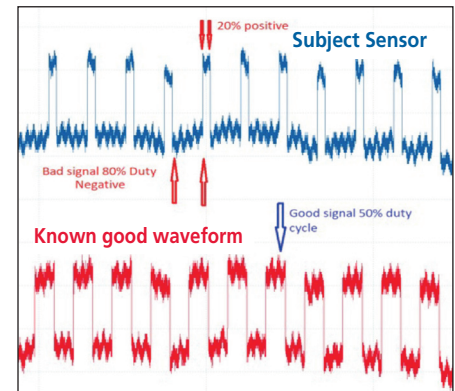
When zoomed into the signal trace, it was seen that the duty cycle of the bad sensor trace was different to the correct sensor trace. A 50% duty was present on the correct signal, but an 80% negative duty was present on the bad side. This gave us some suspicion of possibly a bad sensor or control module fault. We suggested that the suspect sensor be moved to

It was suspected the ECM was picking up on the signal error and possible resetting the ground every 44 teeth. As the signal was so precise in the dropout failure, only a module could control this.

The duty cycle (pulse width) on the subject sensor was different from a known good signal

the left rear loom and retested. The abnormal trace moved to the left rear with the sensor, leaving no doubt that the sensor was faulty. A new sensor was fitted, the fault was cleared and a road test confirmed all was good.
