# Mazda MX-5 - Stiff steering while parking

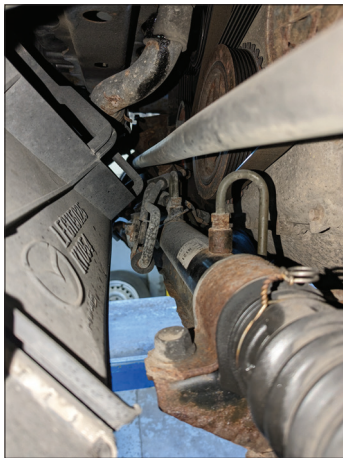
My initial thoughts were that the power steering pump may be weak, but the power steering fluid looked clean. After checking the power steering rack ,I detected lateral movement in the rack assembly. The best course of action was to replace this

**The steering rack is tucked neatly in position**

The job time for replacing the steering rack is 2 hours. After the new steering rack was in place, and the system bled, I could immediately feel the improvement. The power steering assistance could be easily felt.
