No heater fan or rear wiper on a VW UP?

Check the ignition switch

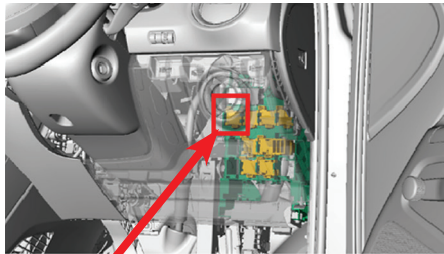
A Volkswagen Up had an interior blower fan that was not operational. On the initial scan, no AC or blower system faults were present.

A diagram was sourced for the climate system to investigate the blower circuit. Using the wiring diagram, it was found the fuse supplying the blower circuit was without power. Backtracking the circuit to the Auxiliary Power Relay, the power supply to terminal 86 was also missing, with the ignition in the run position. Terminal 85 is a permanent earth at this relay. The power supply to this relay terminal 86 comes directly from the ignition switch.

So, if both the heater blower and rear wiper on the VW Up fail, it is common for the ignition switch supply to the Auxiliary Power Relay to be the issue.

The ignition switch was the issue, so a replacement switch was fitted. With the new switch installed, the interior blower worked correctly. As a bonus, the customer had not mentioned that the rear wiper had not worked since the fan had stopped. The power supply for the rear wiper also come from the Auxiliary Power Relay.
