# Non-cranking Skoda Kodiaq with a **DSG** transmission fault

A 2017 Skoda Kodiaq was recovered to Peter Kennedy's Garage in Portlaw, Co. Waterford. The customer has reported that the DSG Gearbox on the Kodiaq was "acting up", and now it would not crank over or start.

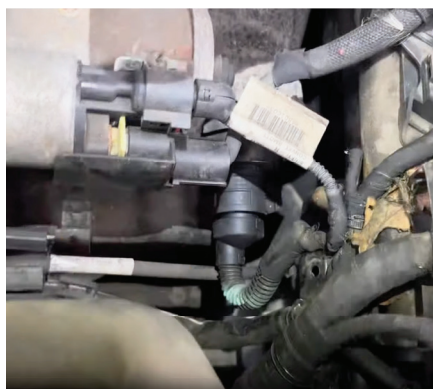
The bonnet was lifted, and the wiring to the gearbox was examined. The Air Box, above the gearbox, was removed to facilitate a good view of the wiring that was connected to the gearbox. On visual examination, there was obvious corrosion on the insulation on the wiring connected to the gearbox. It was likely that some of the wiring to the gearbox was not in perfect condition.

Corrosion was visible on wiring going to the gearbox

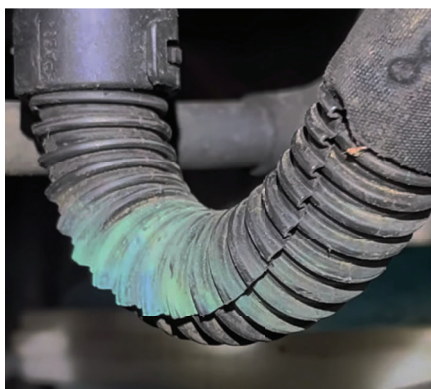
When the wiring insulation was removed, a clear view of the wiring as possible. There was corrosion on some of the wires within the wiring bundle. I suspect that some of the corrosion had compromised one or more of the wires. When I moved some of the wiring, one of the wires broke without much movement at all.

A closer view of the corrosion

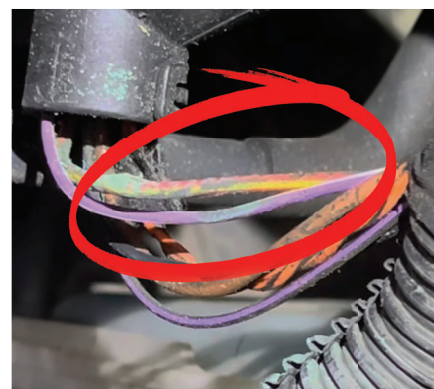
The badly damaged wire (circled) was very obvious, and was easily repaired

The damaged section of the corroded wire was cut out, and a temporary section of wiring was put in its place. With this temporary replacement wire, the car did crank over and it did start.

A replacement wire was permanently installed along with the section of wiring that had been damaged. Care was taken to clean all of the corrosion out of the wiring bundle, and to ensure that the replacement wire was properly positioned and protected from future water intrusion with waterproof shrink tubing.
