# Opel Mokka needed a hard reset

**Tim Stock,**  
Autobiz Helpline

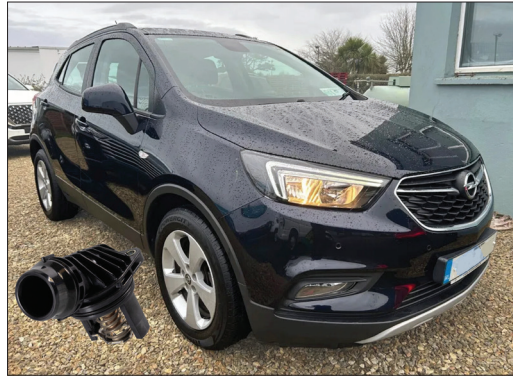
This Opel Mokka X, with a 1.4 litre turbocharged engine, was suffering a water leak from the water pump. While changing the water pump, it was noticed that the thermostat had cracked. The dealership thermostat was on a long back-order, so an aftermarket part was fitted.

An engine management warning light came on after completing the work, while the engine was rising to operating temperature. A scan revealed the fault code P0171 (System Too Lean (Bank 1)) had been logged. The fault code for the lean condition would not erase, and the lambda signals remained low, indicating a lean condition.

At the same time, the temperature at the radiator outlet was showing low. While the engine temperature stayed at 95 degrees C, the radiator outlet was a low 26 degrees.

## Replacing the thermostat in this Mokka proved to be more difficult than expected

This thermostat is an electrically heated mapped unit, controlled by the ECM. Suspecting the non-OE thermostat was the issue, a genuine component was located and fitted, but the issues persisted.

Feeling at a loss, the technician opted to remove the battery for 15 minutes, to perform a hard reset. To everyone's disbelief, the lean code cleared, engine temperature came up to 105 degrees, radiator outlet temperature was a stable 90 degrees, and the radio display cleared the pixelations, and the station memories returned.
