Opel Mokka needed a hard reset

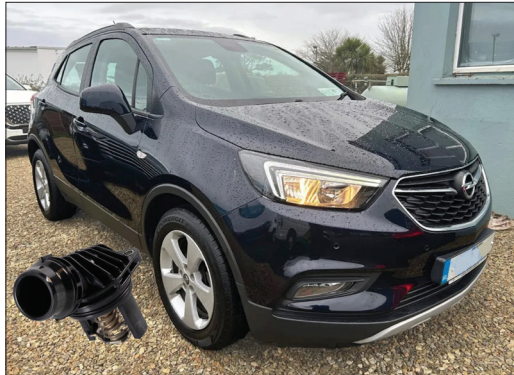
This Opel Mokka X, with a 1.4 litre turbocharged engine, was suffering a water leak from the water pump. While changing the water pump, it was noticed that the thermostat had cracked. The dealership thermostat was on a long back-order, so an aftermarket part was fitted.

This thermostat is an electrically heated

Replacing the thermostat in this Mokka proved to be more difficult than expected

mapped unit, controlled by the ECM. Suspecting the non-OE thermostat was the issue, a genuine component was located and fitted, but the issues persisted.

Feeling at a loss, the technician opted to remove the battery for 15 minutes, to perform a hard reset. To everyone's disbelief, the lean

code cleared, engine temperature came up to 105 degrees, radiator outlet temperature was a stable 90 degrees, and the radio display cleared the pixelations, and the station memories returned.
