Peugeot 307 - Washer Fluid Problem

Ford Fiesta - Seat Release Cable

Audi A4 - Partial Power Loss Problem

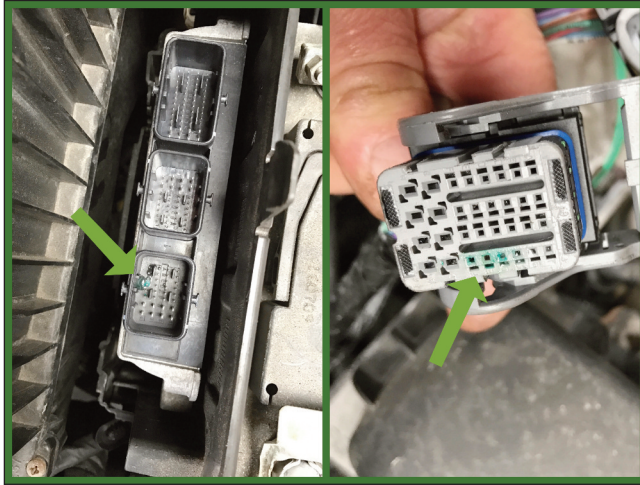
This turned out to be a good move, as when we removed the ECU plugs to check the condition of the connections, we discovered a large puddle of washer fluid.

This was without doubt the source of the

The washer fluid had gone onto the plug, shorting out the connection between the pins. If left for any length of time, the fluid would have caused permanent damage to the ECU.

problem and drying the plug and socket out, we cleaned the area with an electrical switch spray. When the engine was started back up, all the problems had disappeared. Although we have often come across damage to injector plugs due to dripping washer jets, this is the first occurrence we have seen of causing problems with the ECU plug.

We now had to fix the dripping washer hose and protect the ECU from further problems by covering the plugs with a plastic film.

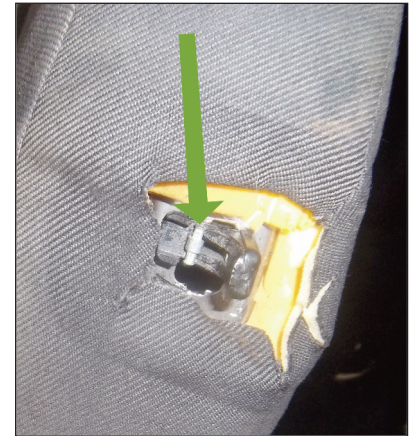
The cable had become detached from the handle

This, at the moment wasn't possible, because the passenger seat would not tilt forward. The problem was due to the cable and tilt release handle. This is a common problem on the two door Fiesta, and with the old handle removed we could see why.

The small end of the release cable was pushed up into the release handle as the lever was lifted. The end on the old cable was worn and this, coupled with the worn plastic of the handle, was allowing the cable to slip through and drop out before it had released the seat catch.

The new cable is slightly modified, and once a new cable and lever were fitted, the seat release mechanism worked without a hitch, allowing the owners precious cargo to be loaded safely from the kerbside of the vehicle.

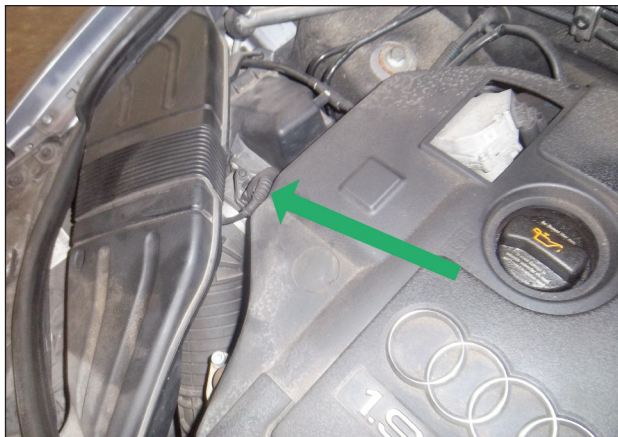
The Air mass sensor plug is easily accessible and after unplugging it we confirmed that the unit was faulty

By unplugging the air mass sensor and giving the motor a quick spin round the block, we found that the power had returned. This is not a definitive test, but very often when the air mass fails, it will set defaults and limit the power. Unplugging it will remove the restriction.

Of course, unplugging the air mass sensor will illuminate the EML. After replacing the unit, we extinguished the light.
