Peugeot replacement BPGA comes incomplete

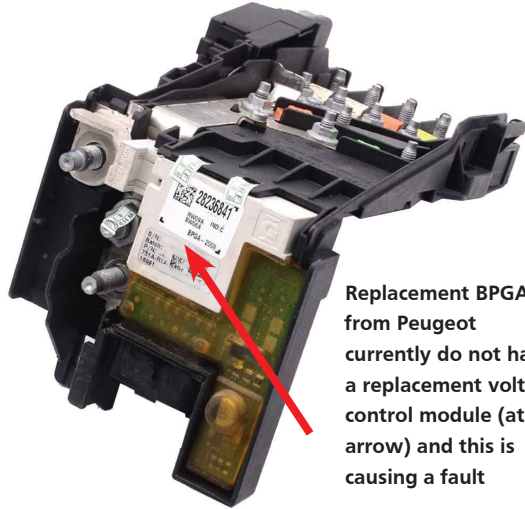
On some models, this can also be a message for an electrical supply fault. We have seen this fault on various models in the PSA group of vehicles in the past. The fault refers to a battery supply and protection unit relay fault. This unit, also known as the BPGA Module, is in the engine bay alongside the vehicle battery.

The BPGA has a voltage control module installed, and this module is not available as a separate component from the dealer. The complete BPGA unit must be replaced. However, the voltage control module is easily removed from the BPGA unit.

Replacement BPGAs from Peugeot currently do not have a replacement voltage control module (at arrow) and this is causing a fault

When the new BPGA was installed, the original fault was gone, but there was now a new fault: F56A Alternator information signal. And the warning message was still displayed on the dashboard.

The Peugeot dealer informed us that this is the correct replacement part, but every customer is having the same issue. As a solution, they are purchasing used voltage control modules to replace the missing component on the BPGA unit.

Considering this information, we are now advising our technicians calling in with this issue not to replace the complete BPGA unit. As this expensive part comes without the actual faulty component installed.
