Renault Zoe refusing to charge

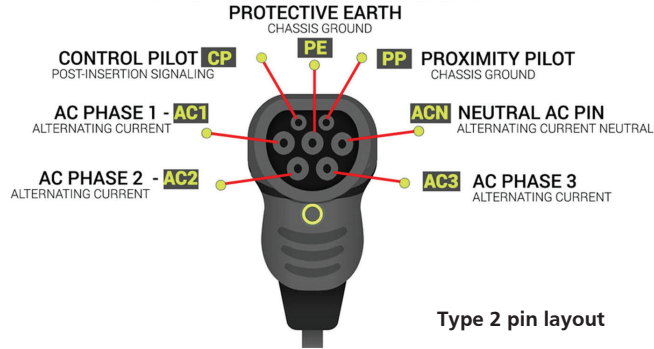
Type 2 pin layout

The charging cable was tested, and found to be good. The Proximity Pilot circuit was showing 1.5kohms to the PE line. The Line and Neutral also tested good. The Control Pilot line, between the EVSE and the onboard charger, would require a scope to monitor the signals between both.

These are 12 volts sent from the onboard charger, and the voltage drops to 9 volts when first connected. When charging is authorized and begins, it drops to a 6 volt, 1 kHz square wave, and the EVSE

sets the duty cycle depending on the current that the charging cable is capable of. In this case, it would be 20% @12amp supply, the maximum the granny charger is capable of supplying
