VOLVO S60 - Lumpy tick-over and into Limp Mode

Rover 75 - Exhaust downpipe disaster

Skoda Roomster - Rear hatch closing problems

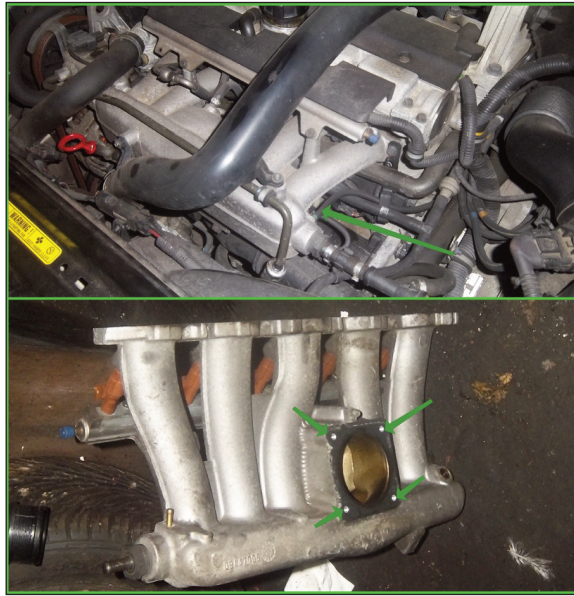
He had used a fuel additive when the problem first developed, but this had no effect on the running. We code read the system to reveal that the problem was due to the electronic throttle body. These can be repaired and so the customer agreed that we should keep the car for a while, remove the throttle body and send it off for repair.

The throttle body sits below the manifold and can only be accessed once the manifold is off

It is then a simple job of disconnecting the throttle body connecting plug and undoing the four securing bolts. The unit was then sent off for repair.

When the unit was returned to us it was refitted, the codes cleared, and the Volvo now ran perfectly.

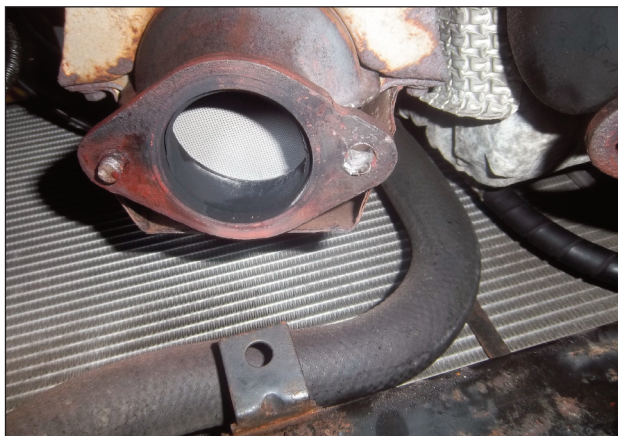
The exhaust leak was from the joint between the catalytic converter and downpipe, and it was clear that the gasket needed replacing.

Once the studs had sheared off they needed to be drilled out

I looked at the securing nuts and decided to try and undo them. That was the big mistake. I had applied a penetrating fluid in an attempt to free off the nuts, but this did not help.

The first nut I attempted to undo sheared. Not content with shearing the first one off, I believed I may have better luck with the second one, but of course I didn't. I now had two sheared studs that needed to be drilled out.

The good news was that both studs were accessible from the back of the flange meaning that once drilled a new bolt could simply be pushed into place. What I should have done of course was to cut up through the side of the corroded nut, allowing it to be removed from the stud. This would have been far quicker and easier than drilling out of the old stud.

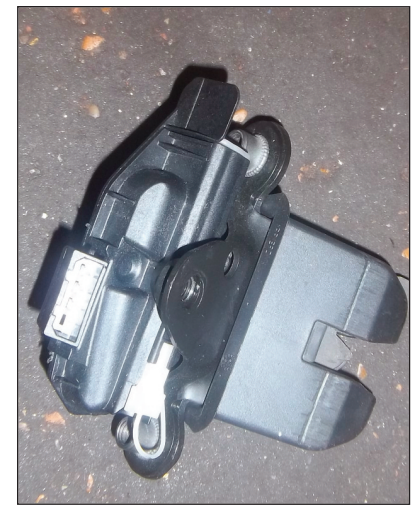
The rear hatch catch is electrically operated and has no mechanical connections

However firmly the owner closed the rear hatch on his 2007 Skoda Roomster, it would occasionally just pop open whilst driving along. It never actually flew up, but would just illuminate the warning light on the dash. The owner got to the stage where he would just ignore the red light until the next stop, and then close it down again.

Problems rarely fix themselves, and the fault developed to the point where the hatch would no longer close properly. At this point, the owner decided it was time to get it fixed.

The rear hatch catch on the Roomster is completely electric and had no mechanical connections at all. The rear trim panel is removed by gently prising off the securing clips, revealing the catch and electrical connector. Disconnecting the electrical plug, we discovered that the catch still would not lock into position, so a new part was ordered. Held in place by three securing bolts, the catch was easily replaced. The unit was not pricey and with the catch replaced, the owner was pleased that he had finally had the job done
