# Touareg cranks and sort of starts

**Peter Kennedy,  
Kennedy's Garage**

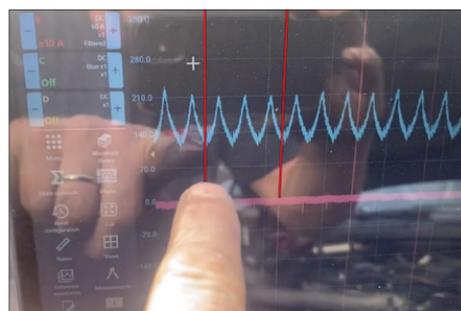
We next thought of an actual mechanical failure, such as the timing chain. We carried out a relative compression test, which at first glance looked perfect. There were nice even peak amperage levels being drawn by the starter motor for each cylinder. On closer inspection, we noticed there were only three compression humps in two rotations (720 degrees) of this engine. This was a V6 engine, so there should have been 6. There was no compression on one bank. The firing order of the engine was 1-4-3-6-2-5. We had no compression on 4, 5, or 6. The bad cylinders were all located on the left bank, and were every other position in the firing order.

**A scope trace on engine cranking showed only 3 compression strokes on this 6 cylinder engine (between red lines is two rotations)**

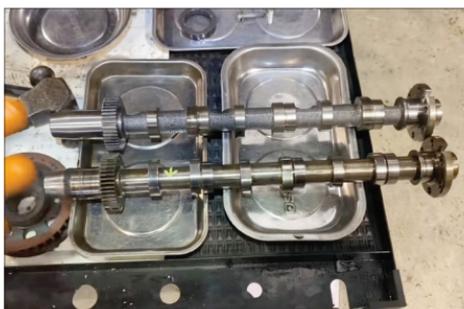
On disassembly of the engine, we found the timing chain was in a good state of repair. It was most likely replaced a couple of years previously. We carried on disassembling, and removed the left bank rocker cover. Once the rocker cover was removed, we were finally able to see something was off. The camshaft lobes had rotated on the intake camshaft. Once the camshaft was removed and compared to a new one, the issue was even more visible. All of the intake lobes had rotated around 90 degrees. We fitted a new camshaft, and reassembled the engine. It was back up and running in no time, much to our relief.

**When compared to a new camshaft, the old cams were noticeably out of position**

The question you have to ask is this: How did this happen? After discussing our findings with the previous garage, we concluded that injectors number 4,5 or 6 had failed badly. This possibly caused a hydrolock situation in one of the left hand bank cylinders. This would have put the intake valves under immense pressure when they were meant to be opening, causing the intake lobes or pulley to rotate on the camshaft axis.
