Golf - Manifold fault

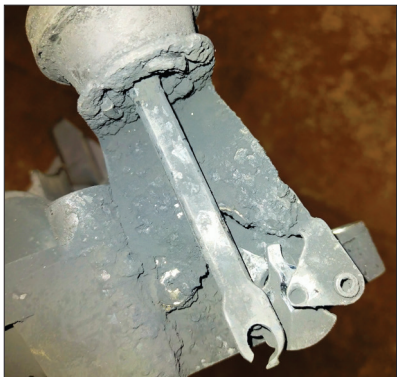
I found code P2015, indicating an intake manifold air control actuator position sensor/switch, bank 1 - range/performance problem. This is normally a mechanical problem, as opposed to a short or sensor fault. So I made an inspection of the inlet manifold.

This didn't take too long and I had soon spotted the reason for the code and the performance problems. The answer was to fit a new inlet manifold. With most of the bolts easily accessible, the book time is just over an hour.

Once assembled and the codes cleared, the Golf was fit to go.
