# VW Amarak Gearbox or Bearing Noise?

**Peter Farrell,**  
**PJF Motors, Tuam**

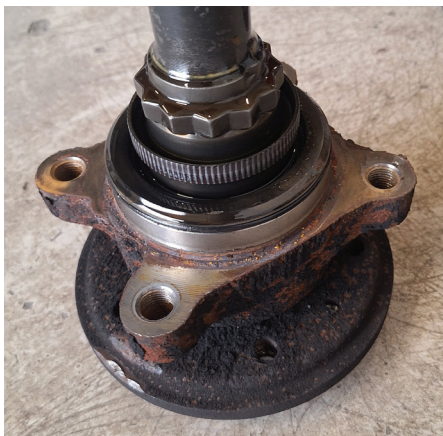
**The wheel bearing and ABS sensor ring are held in place with a crimped nut threaded onto the axle shaft**

Each wheel bearing is kept in place by a locking nut. Be aware that there are right hand threads on the locking nut on the right axle, but there are left hand threads on the locking nut on the left axle. After properly torquing the locking nut onto each axle, the top thin edge of each locking nut should be dimpled into both keyways, on each axle shaft. This prevents the nuts from tightening or loosening as the axles rotate.

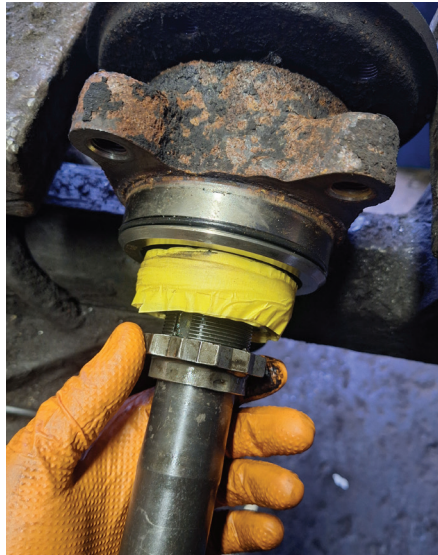
**Cover the teeth of the sensor ring to protect them from foreign objects**

Both axles were removed, and both wheel bearings replaced. There are some precautions that should be made while replacing these wheel bearings. With each axle removed from the Amarak, the next step should be to use electrical tape to cover the ABS sensor ring. This prevents any foreign objects from dropping into the gears during handling. Foreign objects will cause an ABS wheel speed sensor fault after re-assembly.
