# VW Tiguan hybrid coolant plus aircon problem

The Autobiz Helpline was contacted by a member garage about a Volkswagen Tiguan 1.4 eHybrid. The Tiguan was booked into the workshop for two problems.

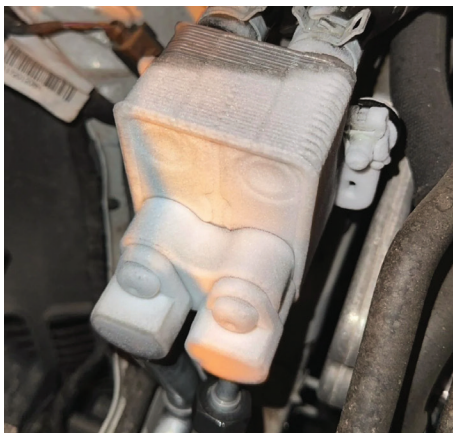
Checking on known issues with low coolant on these models came up with a possible culprit, the heat exchanger on these Tiguans is known to leak internally.

**The expensive heat exchanger was tested and proved to be faulty before it was replaced**

As this cap was being removed, the technician observed the system was pressurised, even though it had not been run that day. The scan tool showed an extremely high concentration of refrigerant present. This proved without a doubt that the heat exchanger was leaking between the coolant and refrigerant circuits.
