Cam tensioner **pulley fracture** problem

The adjustment cam on the tensioner pulley can fracture during the tensioning process. Continental has provided these instructions for timing belt kits CT1168K1/ K2/ WP1/ WP2/ WP7/ WP9/ K6PRO/ WP8PRO that are for VW, Audi, Seat, Skoda EA288 1.4–2.0 TDi common rail engines.

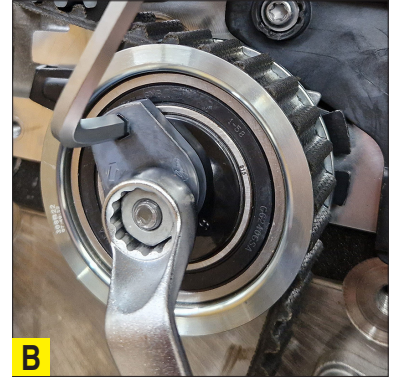
The cause of this fracture is that the fastening nut is over tightened during assembly. As a result, the nut turns together with the eccentric cam during tensioning, subjecting it to an even greater load. This produces too much resistance, causing the adjustment cam to crack (**Fig. A**).

The solution is to only tighten the nut by hand prior to tensioning. Use an appropriate tool to hold the nut securely (**Fig. B & C**) so
