## Installation Tip for WPS3025 Coolant Pump for BMW 135i, 335i, 535i, 640, 740i from model year 2007

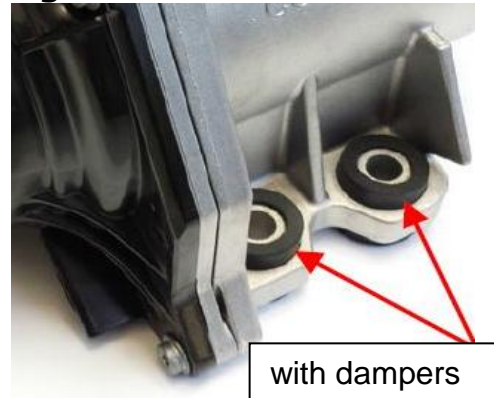
**Fig. 1**

The electric coolant pump which has been removed may have prefitted dampers at the three screw-fastening points (Fig. 1). The new WPS3025 coolant pump does not have these. The old fastening bolts are not suitable for reuse.

The aluminum bolts which have been removed (M8x36) must not be reused, but must be replaced with shorter steel bolts (M8x26).

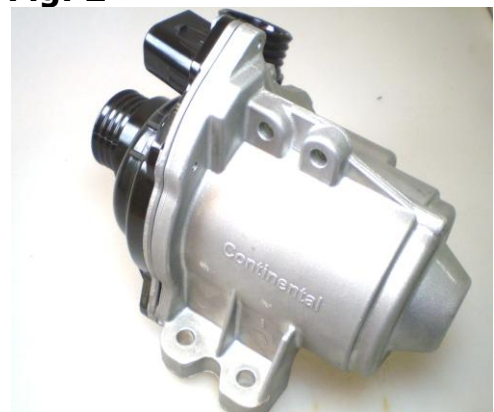
**Fig. 2**

The vehicle manufacturer has changed the coolant pump over to this new design without dampers (Fig. 2).
