New VAG belt noises

Following the installation of the timing belt on some Audi, Seat, Škoda and Volkswagens with 1.6-2.0l 8V engines, noises may be heard from the area of the timing belt. Continental offers technical details to correct, or avoid this situation from occurring.

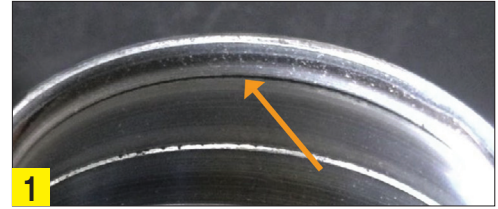
The noise is most likely caused by one side of the timing belt rubbing against the tensioner pulley's flange (Fig. 1). The tensioner pulley's outer surface may show signs of the belt running off-centre. (Fig. 2). This indicates that the belt is not properly seated on the engine's sprockets.

To solve this noise problem, carry out tensioning in accordance with the manufacturer's instructions.

- The manufacturer's instructions for tensioning must be observed.
- The tensioner pulley must be tightened to full load five times in succession ((Fig. 3 and 4) with the belt fitted. This will cause the tooth profile to engage fully in the sprockets.
