# Technical *Info*

## Installation of the timing belt kit CT 1045 K1 for Renault 1.2 16 V

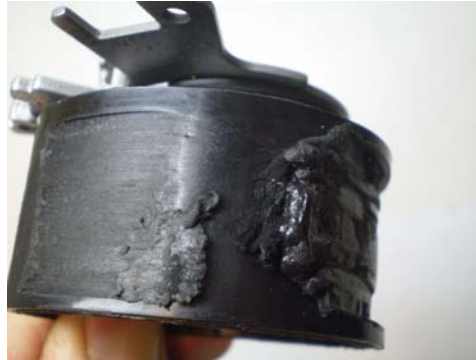
Fig. 1

The tensioner pulley collapses after a short running time and possibly has a separate barrel jacket from the bearing core. The barrel jacket has mostly strong traces of rubbing. The back of the timing belt is often considerably damaged, and sometimes even completely worn due to heat application.

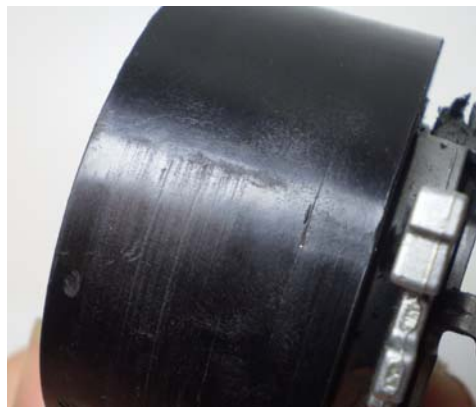
Due to the eccentric being rotated in the wrong direction, the tensioner pulley reaches an impermissible position and makes contact with a protruding edge in the motor pinion.

The tensioner pulley is thereby completely or partially mechanically blocked and the belt which continues to turn is overheated on the barrel jacket. The level of damage depends on the running time.
