Chrysler PT-Cruiser Model year 2001-2003 Without turbo engine

Service connections

Bulletin

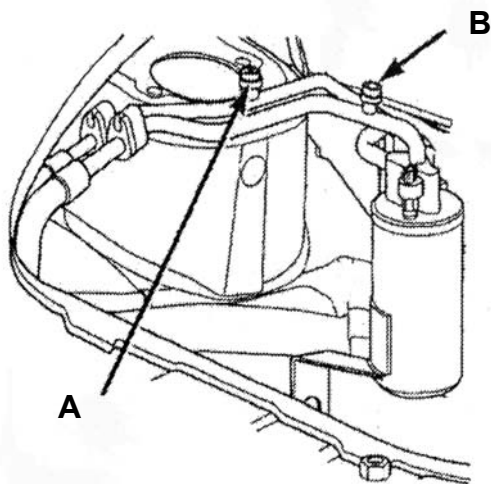
With the above-mentioned vehicles, there is some confusion due to the number and arrangement of the service connections. The high-pressure-side connection marked "A" in the drawing is the high-pressure connection attached for filling of the system in the factory. It is on the low-pressure part of the system, however. To avoid faulty measurements and damage to the system, this connection must not be used to check the high pressure or to evacuate/fill up the refrigerant. The actual high-pressure connection is on the high-pressure line near the compressor. Vehicles manufactured before July 2000 (chassis no.: MDH0710XX) do not have this connection, however. In these cases it is not possible to check the high pressure or to carry out a high-pressure-side evacuation/filling-up of refrigerant easily. The installation of a high-pressure line (with service connection) that has been modified by the factory can solve the problem here. The connection marked "B" in the drawing is the low-pressure service connection.
