Chrysler Voyager II (GS) Model year : 1995–2001 Engine : 3.3 i

Automatic transmission does not change gear / speedometer not working

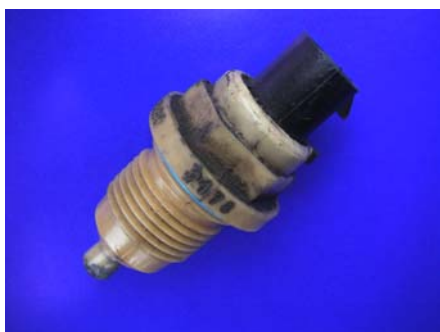
Fig. 1

If, in the case of the above-mentioned vehicles, the automatic transmission no longer “changes up” in the gears D, 3 and L and if at the same time the speedometer fails, this may be connected with the failure of a speed sensor (Fig. 1). Before replacing the speed sensor, which is located at the front of the transmission (above the oil pan) (Fig. 2), it is recommended that the wiring and the plug-connection be checked. The sensor can best be reached from underneath. To make access easier, the cable loom which runs past this area should be pushed to the side, after removing the fastening straps. The new sensor must be tightened to a torque of 7 Nm. The cable loom must then be put back in its old position and refastened.
