Citroen C2

All vehicles with power steering year of manufacture until December 2007

Failure of the power steering

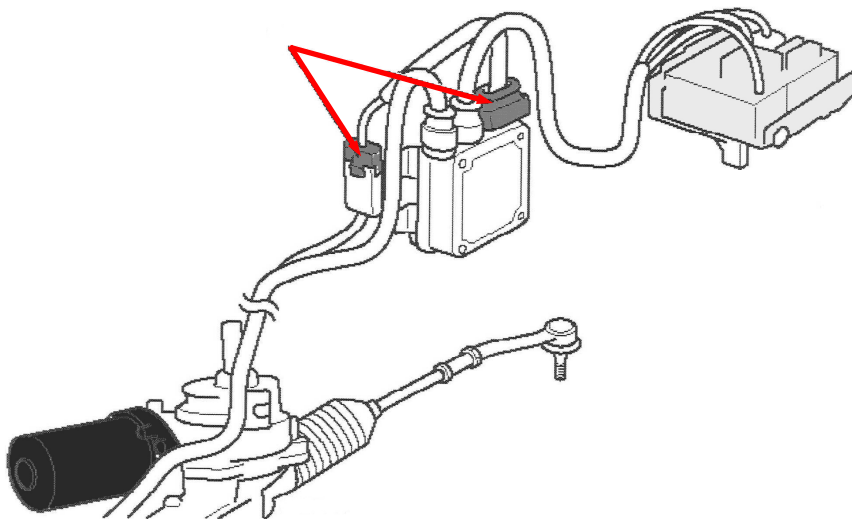
If a customer complains about the above problem, this could be caused by a defective torque sensor. The customer notices this defect by an increased steering effort . In addition, the error codes C 1400 and C1413 (torque sensor, signal error, torque sensor, malfunction) may be stored. Before replacing the torque sensor, the connectors at the control unit of the electric power steering should be checked for proper seat (see illustration). The above problem may also be caused by a poor contact.
