Citroen Jumper II With 2.8 HDI engine From serial number 17443608 to 17545710

Vehicle starts poorly

Bulletin

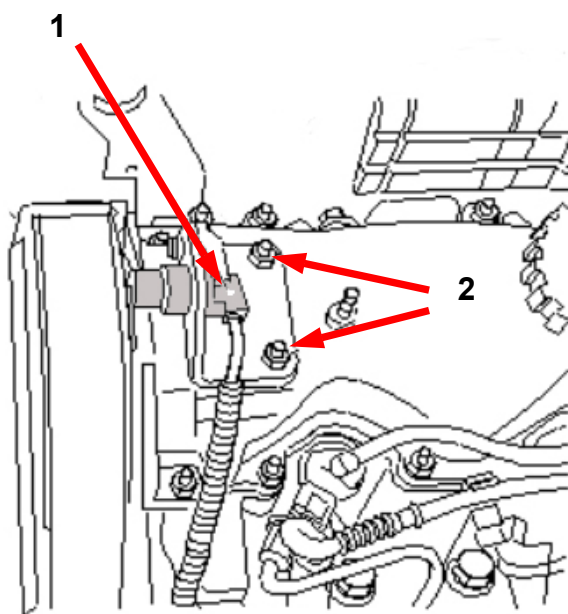
Fig. 1

If there are complaints about the above-mentioned fault, the cause could be incorrect positioning of the camshaft sensor. This leads to the engine starting poorly. Due to incorrect geometry of the retaining clamp for the camshaft sensor, the distance between sensor and camshaft pulley is too great. In this case, the position of the sensor must be corrected with the aid of two washers. These washers, with a very particular "thickness", can be obtained via the manufacturer.

- Disconnect the battery.
- Remove the engine cover.
- Remove the plug (see Fig. 1, Item 1) from the sensor.
- Unscrew the fastening nuts from the holder (see Fig. 1, Item 2) and remove the holder upwards.
- Fit a washer to both stud bolts.
- Refit the sensor holder. Initially however, tighten the fastening nuts only lightly, so that the holder can still be moved.
- Now line up the holder such that the distance between the sensor and the reference mark on the camshaft pulley is 0.8–1.5 mm (see Fig. 2).
- Tighten the fastening nuts.
- Refit removed parts in reverse order.
