Fiat Idea 1.4L Model year from 2004 to 2006 Vehicle identification no. from 0005007 to 00065546 All automatic-transmission vehicles

Defective automatic transmission, stiff gear selection

Bulletin

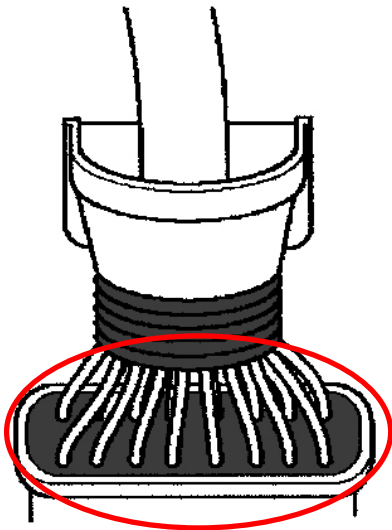
Fig. 1

If there are complaints about the above-mentioned fault, the cause could be a leaky multi-plug. Due to water ingress into the multi-plug of the transmission wiring harness, the above-mentioned fault occurs. In this case, proceed as follows:

- Remove the multi-plug of the transmission wiring harness.
- Pull back the rubber boot. Pull the rubber seals of the pins out of the plug and check the pins for corrosion. If necessary, clean the pins (see Fig. 1).
- Dry the plug and the pins.
- Properly press the rubber seals of the pins into the plug housing again.
- Fasten the rubber boot onto the plug housing again.
- Wrap insulating tape around the thinner end of the boot.
- After this, use a cable clip to secure the boot at the thinner end (see Fig. 2).
- Refasten the multi-plug and check the system for perfect operation.
- Use a cable clip to fasten the multi-plug, in order to avoid possible contact problems (vibrations) (see Fig. 3).
