Fiat Punto Model year from 1999 to 2001 All vehicles with electrical power assisted steering (City function)

The warning light of the electrical power assisted steering lights up

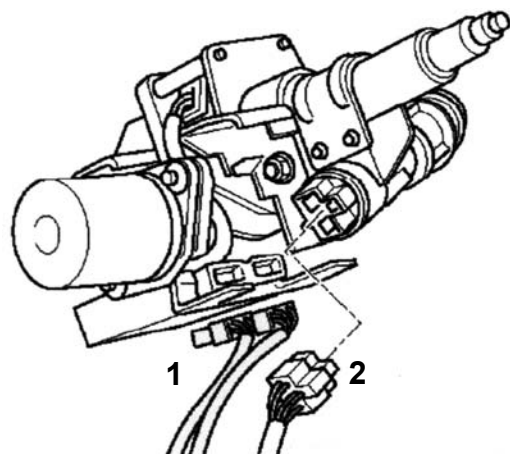
If there are complaints about the above-mentioned fault, a poor plug-type connection could be the cause. Poor contacting at the blue 2-pin (1) and black 10-pin (2) connector leads to repeated interruptions, but a fault is not stored. The connectors are beneath the steering column (see fig.). In this case the connectors have to be "reworked" in such a way that secure contacting is guaranteed. To do this separate the plug-type connection and press the individual cable lugs together with the aid of a small screwdriver in such a way that higher contact pressure is achieved on the individual pins. Reinsert the connector and check the correct function of the power assisted steering.
