Ford Scorpio, from model year 03.1995 All petrol engine models

Fuel gauge defective

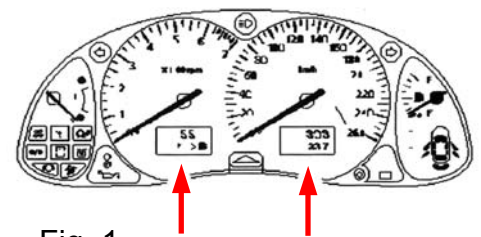
Fig. 1

If there are complaints about the above fault, the cause could be a broken instrument cluster printed circuit board. The fault manifests itself by the needle deflecting so far that it touches the plastic housing.

The following test steps should however be carried out before exchanging the instrument cluster:

- Switch on the position lights for at least 30 minutes, so that the printed circuit board warms up.
- Activate the instrument cluster self-test as follows.
 - o Switch on the ignition.
 - o Press and hold the trip meter reset button for at least 6 seconds.
 - o When all symbols are visible in the displays for the tachometer and speedometer, the self-test is activated (see Fig. 1).
- Switch the ignition off and on again and watch the fuel gauge.
 - o If the needle deflects so far that it touches the housing (see Fig. 2), the printed circuit board is broken and the instrument cluster must be replaced.
 - o If the needle moves very quickly to “full”, then to “empty” and then back to the current fuel level, the printed circuit board is OK.
