## **Hyundai Accent, Model year: 2000–2002, 1.5-litre and 1.6-litre engine**

### **Engine control lamp illuminates**

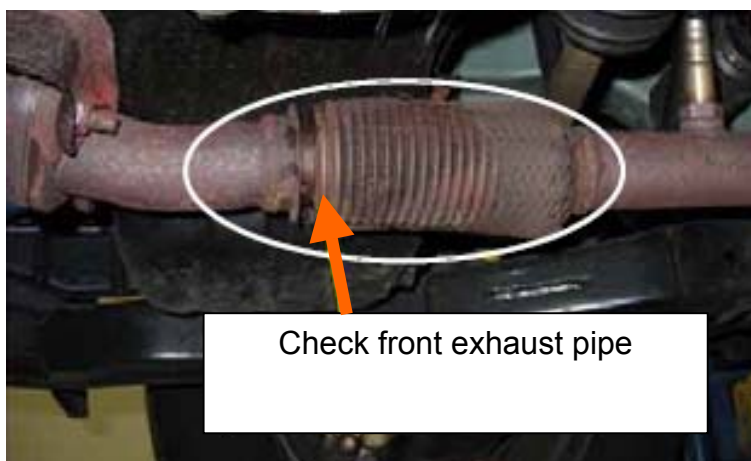
Fig. 1:

If a fault is shown via the control lamp and the fault code “P0133 lambda probe bank 1 sensor 1 reaction time too high” is found when checking the fault memory, a check should be made as to whether the front exhaust system between the two lambda probes is alright and tight.

A hole in the pipe can lead to the control unit classifying the front lambda probe as defective.

1. Check the exhaust pipe for tightness (Fig. 1)
2. If necessary, replace the front exhaust pipe
3. Bring the engine to operating temperature, monitor the probe signal on the oscilloscope. If the engine speed reaches more than 2,500 1/min, the switching rate must increase (Fig. 2)
4. If the scope trace corresponds to the illustration; the lambda probe should not be replaced.
