## Land Rover Defender model year: 06/1998 - 2004 Discovery II model year: 01/1999 - 2004 With diesel engine: Td5

## Engine warning light illuminates / no engine throttle response

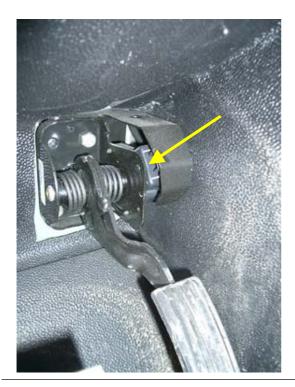
If the engine warning light illuminates on the above vehicles when driving, and if there is no throttle response, this may be due to a faulty plug-connection for the accelerator pedal sensor on the accelerator pedal (see picture). Firstly, a check should be made as to whether the sensor connector is truly locked into place, and cannot be removed. If the problem is still present even after checking the plug-connection, the fuses should be checked, and the accelerator pedal sensor should be checked with the aid of a circuit diagram.
