Bulletin

Lexus RX300 Model year: 1998 – 1999

Rattling noises

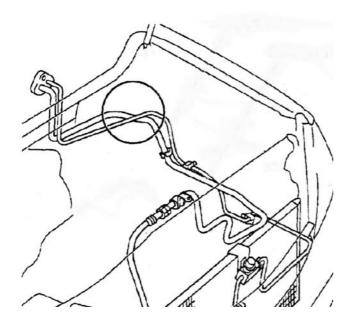
If rattling noises from the engine compartment should be heard inside the passenger compartment, this could be caused by refrigerant lines lying on top of one another. The noises can be heard particularly clearly when the compressor is switched off. To remedy the problem, check the refrigerant lines in the engine compartment (area circled in the drawing). If the lines are too close together, the area should be insulated or sheathed using appropriate material, such as sponge tape, Hella part no. 9MJ 351 018-011.
