## **Mercedes Benz A-Class (W168) With engine 166**

### **Misfires when accelerating**

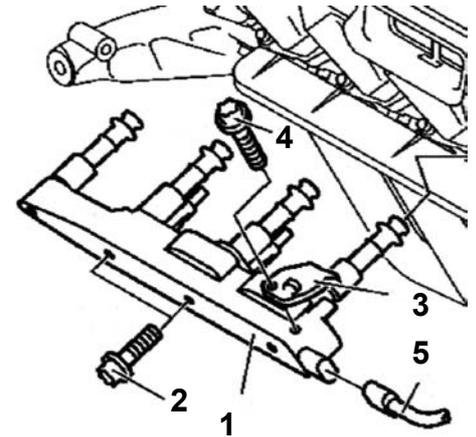
If there are complaints about the above-mentioned fault, the reason could be a faulty ignition module. As a result of the influence of temperature and moisture, cracks in the ignition module can lead to high-voltage spark-over. In addition, fault codes P0300 and P0304 are stored.

- Remove the old ignition module.
- Insert the new ignition module evenly on the spark plugs.
- Tighten the ignition module (1) attachment screws until the screw heads are flush. Then tighten the screws (2) alternately in such a way (torque: 20Nm) that the ignition module is flush to the cylinder head **without tension**.
- Tighten the holder (3) on the ignition module and then mount it to the cylinder head hood using the attachment screw (4, torque: 8.5 Nm).
- Reconnect the electrical plug-type connection (5) to the ignition module.
- Delete the fault memory.

To improve heat and moisture protection, the manufacturer supplies an additional protective hood and heat dissipation shield that should be installed in such cases.
