Mercedes C-Class (W 203) All vehicles above model year 02/03

ESP/ABS pilot lamp lights up

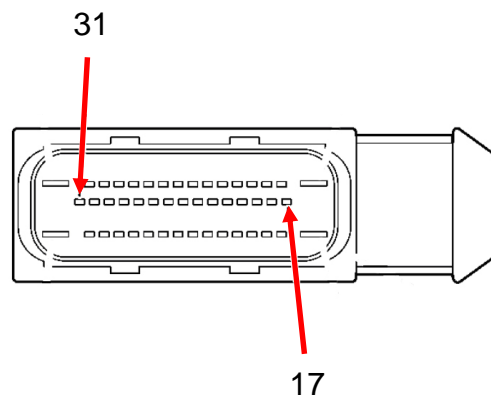
If a customer complains about the above error, this could be caused by a corroded plug connection. Error codes C1140 (steering wheel angle sensor, incorrect signal) and C1145 (ABS wheel speed sensor VR, interruption) may occur.

1. Check connector pins 18, 19 and 20 (all three on the brake pressure sensor) of the plug connection on the ABS/ESP control unit (see Fig.); clean and dry if necessary. The control unit is located in the left side of the engine compartment in the control unit box behind the spring dome.

2. If damage is already severe, use the repair kit to replace the pins.
3. Treat the plug connection with electronic spray or grease before contacting.
4. Check the wiring harness of the brake pressure sensor for continuity. Max. resistance is 0.5 Ohm.
