Mercedes Benz C-Class (W202)

Airbag (SRS) light permanently on

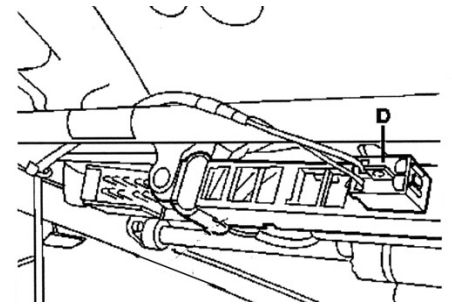
Fig. 1

If there are complaints about the above-mentioned fault, the cause could be a loose plug connection. If cables have not been laid correctly, the plug connections (D) on the contact strip on the left or right under the seat (Fig. 1) can become loose from the contact strip when the position of the seats is adjusted. In this case, the cables must be re-laid. In addition, the fault codes 5 or 6 could be stored.

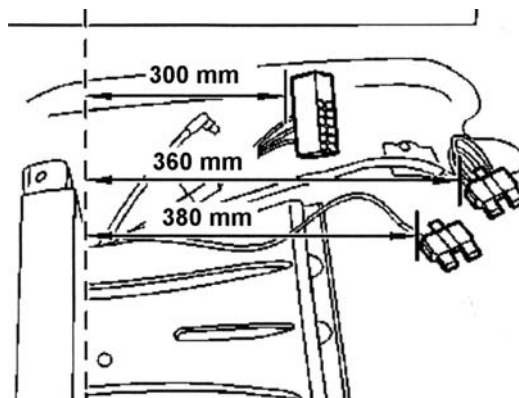
Fig. 2

300 mm :
Cable for electric seat
adjustment

360 mm:
Cable to seatbelt
lock

380 mm:
Cable to seat heating

- Pull the cable plugs off the contact strips.
- Measure the length of the cables from the plugs to where they enter the carpet
- Correct the cable lengths if necessary (Fig. 2)
- After checking or correcting the cables, fix them in the cable shaft again using cable ties
- Delete the fault memory
