## **Mercedes Benz M-Class (W163) Type 163.136/154/172 .A from 057949 to 085961**

### **Engine doesn't start**

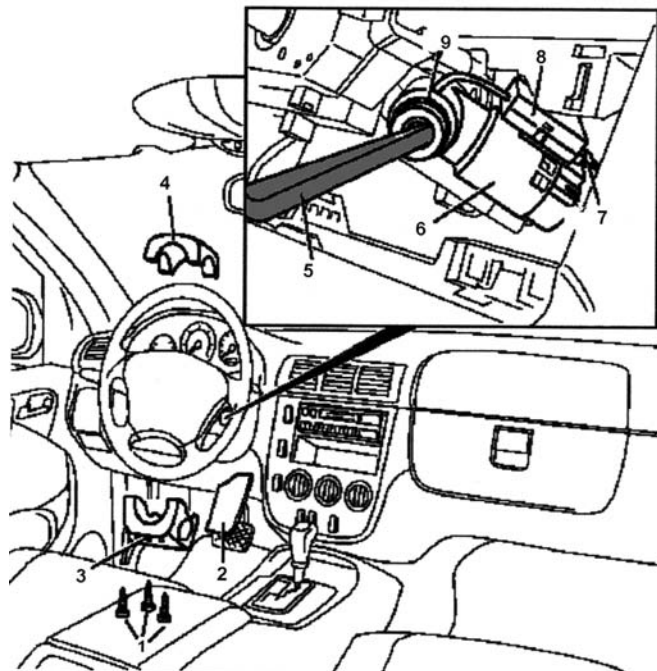
If there are complaints about the above-mentioned problem, a faulty transponder coil could be the cause. This problem occurs more often at low temperatures. In addition, the fault codes P1570 and B1703 could have been stored. In this case the date on the transponder coil has to be checked. If the date is before week 49 in 1998, the coil has to be replaced. Proceed as follows:

- Clip out the cover (2) to the right of the steering column.
- Remove the screws on the steering wheel skirt (1).
- Remove the steering wheel skirt (3 and 4).
- Push the control unit (8) out of the bracket of the ignition switch (6).
- Loosen plug-type connection (7).
- Push the transponder coil (9) off the sleeve of the ignition switch with the aid of a small wedge (5).
- Remove the control unit with the transponder coil.
- Mount new coil with control unit and attach parts again in reverse order.
- Delete fault codes.
- Check system for function.
