## **Mercedes Benz M-Class (W163) Type 163. ... .A from 145273 Type 163. ... .X from 708319**

### **SRS warning light comes on**

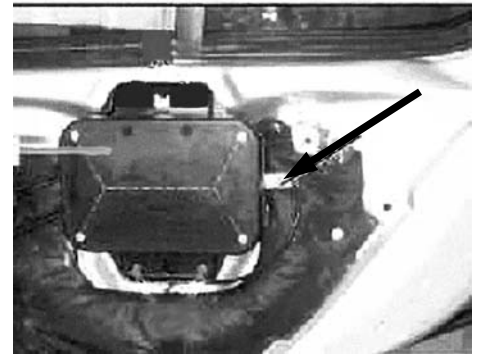
If there are complaints about the above-mentioned problem, a faulty contact on the side airbag could be the case. Faulty plug locking on the airbag unit (see figure) leads to this problem. In addition, the following fault codes could have been stored:

- B 1867 (squib, airbag front left).
- B 1869 (squib, airbag rear left).
- B 1871 (squib, airbag front right).
- B 1873 (squib, airbag rear right).

- Delete fault codes using the diagnosis tester.
- Remove side panelling.
- Select the menu "measuring values/parameters" in the diagnosis tester.
- Select the sub-menu airbag/ignition circuit.
- Shake the plug connection and watch the values. If the values change, the plug connection has to be replaced.
