Mini R50 / R52 / R53 (Cooper S)

Poor cooling performance of the air-conditioning system

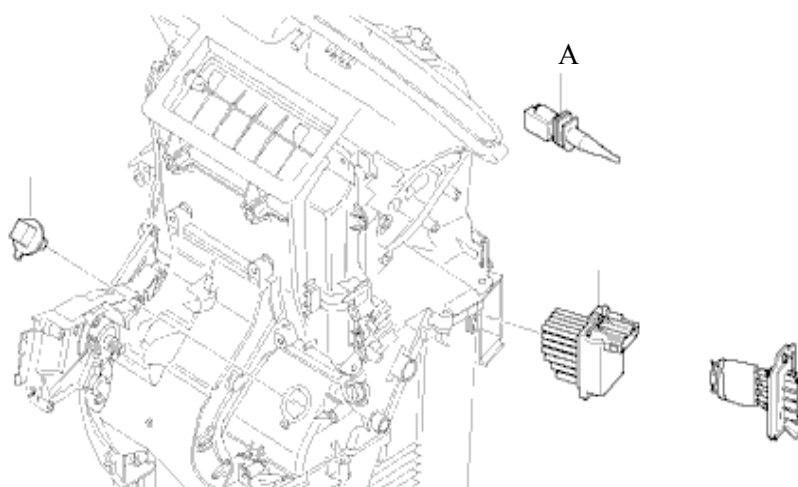
With the above-mentioned vehicles, a faulty evaporator temperature sensor can lead to poor cooling performance of the air-conditioning system.

Before the sensor is replaced (drawing, pos. A), an air-conditioning service unit should be used to check the pressures in the system, and the refrigerant levels should also be checked if necessary.

The sensor can be checked using a diagnostic unit and the measured value blocks are then read out. If the value displayed (e.g. -30°C) is implausible, faulty cabling or a faulty sensor can be assumed. Alternatively, the resistance values of the sensor can be checked using a multimeter and compared with the reference values.

The sensor has been modified by the vehicle manufacturer.

Old part no. (up to April 2004): 64511499136

New part no. (from April 2004): 64116943846
