Bulletin

8 January 2007

Opel Meriva 1.4 L All models with a Bosch coolant temperature sensor

Poor engine running

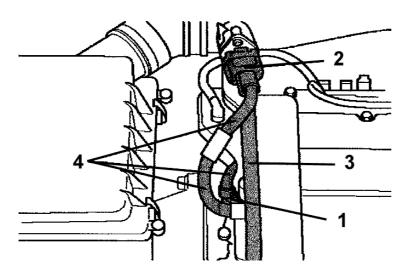
Fig. 1

If there are complaints about the above-mentioned fault, the cause could be a faulty plug-connection for the coolant-temperature sensor. Vibrations can cause a loose contact in the plug-connection. The symptoms of this are as follows:

- Disconnect the battery.
- Remove the plug-connection from the temperature sensor (see Fig. 1, Item 1) and from the air mass sensor (see Fig. 1, Item 2).
- Remove the cover (see Fig. 1, Item 3).
- Remove the plastic sheathing and the insulating tape from the wiring harness (see Fig. 1, Item 4).
- Cut through the cable of the temperature sensor and remove the cable from the cable duct.
- Cut the cable of the repair kit to a length of at least 120 mm.
- Lock the connection contacts into the new plug housing (see Fig. 2).
