Opel Sintra From model year 1997

Wiper arm moves beyond the A-pillar.

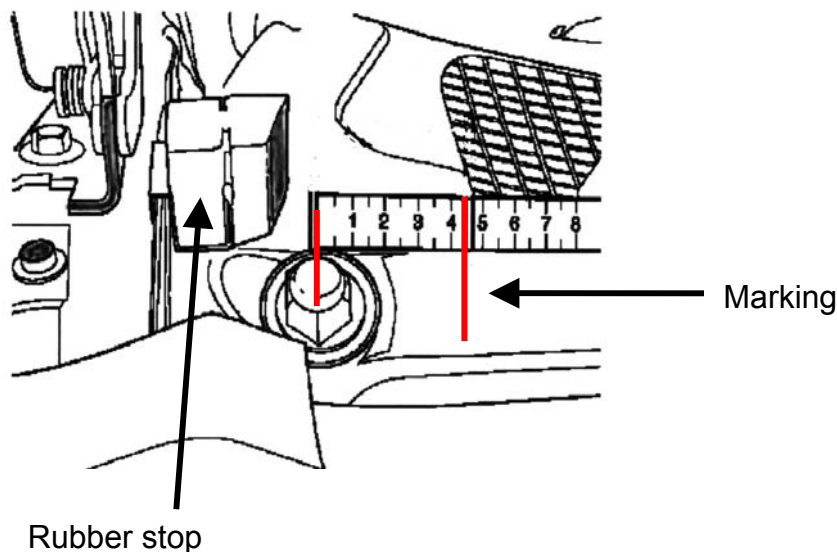
If there are complaints with these vehicles that the right-hand wiper arm moves beyond the A-pillar at high speeds, this could be due to a rubber stop being missing. To eliminate the problem, a new rubber stop has to be installed. To do this proceed as follows:

- Mark the spot on the wiper arm 4.5 cm away from the pivot point of the right-hand wiper arm using adhesive tape or non-permanent ink (see photo).
- Switch on the ignition, activate the wiper switch. Switch the ignition off again when the wiper arm is in the vertical position.
- Mount the rubber stop aligned to the centre of the marking on the wiper arm (see drawing).

In addition, the attachment screw should be checked for a tight fit.
