Opel Vectra C **All models with xenon headlamps**

Headlamps adjusted too high

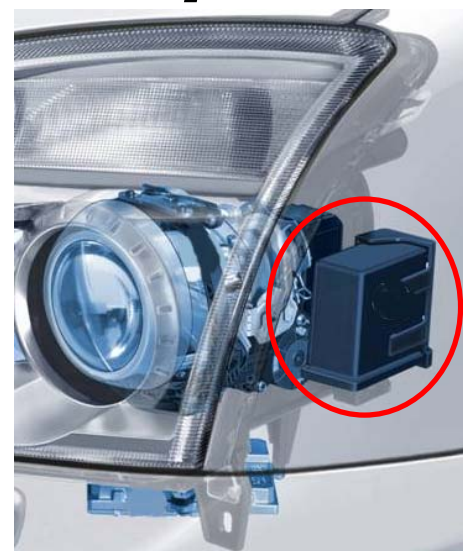
Fig. 1

If there are complaints about the above-mentioned problem, a faulty control unit (headlamp levelling) could be the cause. After the dipped beam has been switched on, both headlamps usually move through a “reference run” to the lowest possible position, pause there briefly and then move to the so-called “zero position”. This is the cut-off line. In the case complained about, both headlamps move downwards. One of the two headlamps does not pause there briefly, however, but moves straight back up again. The headlamp that paused in the lower position then moves up into the “zero position”. The headlamp already in the “zero position” then also moves upwards again, which means this one is adjusted too high. This can easily be checked using a beamsetter. In this case the headlamp levelling control unit must be replaced (see Fig. 1).

- Remove the attachment screws and retaining clip of the front trim on the left-hand side.
- Pull the trim out of the guide rail and press it downwards carefully.
- Unlock the cable connector for the headlamp voltage supply and pull it off.
- Unlock the control unit cable connector and pull it off.
- Remove three screws from the headlamp and remove the headlamp carefully.
- Remove three screws (see Fig. 2) from the headlamp control unit and remove the control unit and cap. Fit a new control unit with bracket and cap.

- Refit the control unit connector and the connector for voltage supply.
- Install the headlamp. When tightening the screws make sure that the headlamp/bonnet gap is parallel. Max. screw torque = 2.5 Nm
- Insert the front trim back into the rail and fix in place.
