## **Peugeot 306** **From model year 02.1996**

### **Airbag light illuminates**

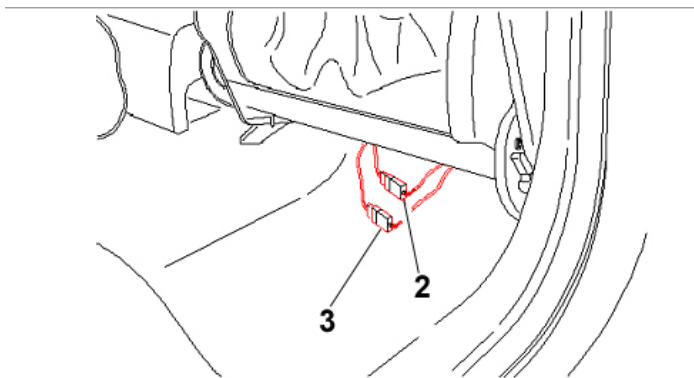
Abb. 1

If there are complaints about the above-mentioned fault, faulty plug connections on the airbag/seatbelt wiring harness could be the cause. In this case proceed as follows:

- The wiring harness plug connections are under the seat.
- Loosen the plug connection (orange) on the seatbelt tensioner wiring harness (see Fig. 1 item 2).
- Loosen the plug connection on the side airbag wiring harness (see Fig. 1 item 3).
