Peugeot 407 With 2.0 HDI engine (DW10BTED4)

Vehicle cannot be started up, battery discharged.

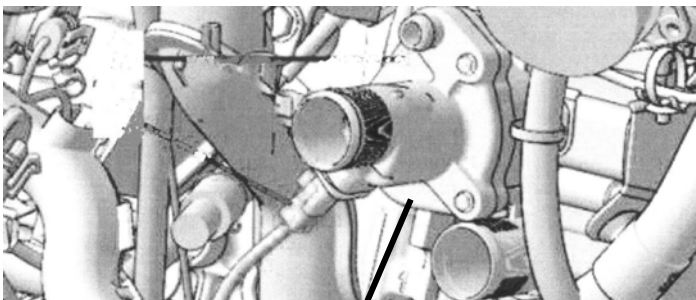
Coolant filler neck

If there are complaints with these vehicles that the battery is discharged, one possible cause is a short-circuit in the plug of the engine control unit. This is caused by a leak at the coolant filler neck which has the temperature sensor screwed into it. Coolant enters the wiring harness on account of the leak between the coolant filler neck and the temperature sensor. By capillary action, the coolant reaches the plug at the engine control unit and causes corrosion there. This particularly affects pins E1 and F1 which leads to permanent activation of the pre-heating control unit and battery discharge. To eliminate the fault, the coolant filler neck must be replaced and the temperature sensor plug disconnected. The plug is attached to the retaining shackle on the coolant hose using a blind plug.

The plug on the engine control unit has to be cleaned. If oxidation is so advanced that cleaning is no longer possible, the complete wiring harness has to be replaced.
