Range Rover III (LM) Model year: 2002–2004

Poor cooling performance / Loss of refrigerant

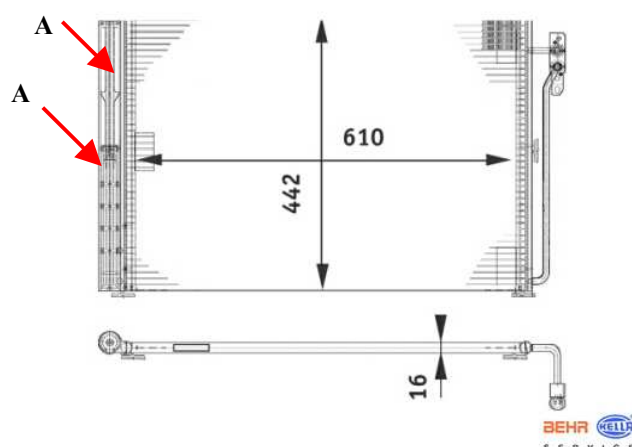
If poor cooling performance or a loss of refrigerant is found in the case of the above-mentioned vehicles, one possible cause is a leaky condenser. A so-called condenser-dryer module is used in the case of these vehicles. This means that the dryer is located directly on the condenser. In this case, the dryer cartridge (Item **A** on the drawing) can be replaced separately. Sometimes, a white substance can be seen in the area of the threaded cap, the holder for the dryer cartridge. This is attributable to residues from the soldering process. As a result of this, there is a risk of the threaded cap not sealing sufficiently and of corrosion arising. In the event of leaks, usually only the replacement of the entire condenser helps. Condensers and dryer cartridges for this vehicle can be found in the *Behr Hella Service* spare-parts range.
