Range Rover Sport V8 – 4.2L(2006-2008) and LR3(2005-2008)

Noise (creaking/squeaking) in the area of the dashboard

Bulletin

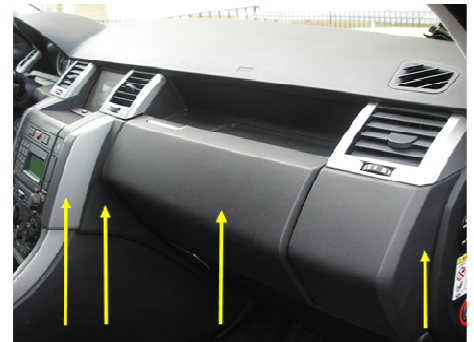
If there are noises in the Range Rover Sport (see above for model series), such as creaking and squeaking, in the area of the dashboard, the precise cause is difficult to determine; it is probably caused by dirt build-up between the driving shafts of the recirculation flap. This noise increases appreciably when the air conditioning is switched to recirculation.

- Lubricate the recirculation driving shafts.
- To do so, remove the glove compartment, the side cover of the audio system, the cover panels of the right centre console and the cover panels of the glove compartment (see photo for positions).
- After removing these parts, turn on the ignition and set the air conditioning to fresh air.
- The driving shafts are now visible.
- Turn off the ignition and lubricate the rods with appropriate lubricant.
- Turn the ignition back on and switch the air conditioning from fresh air to recirculation mode several times (up to 10 times).
- If the noise does not occur any longer, reinstall the parts.
