## **Renault Megane II and Scenic I Only vehicles without headlight cleaning system**

### **Warning lamp for the headlight cleaning system illuminates.**

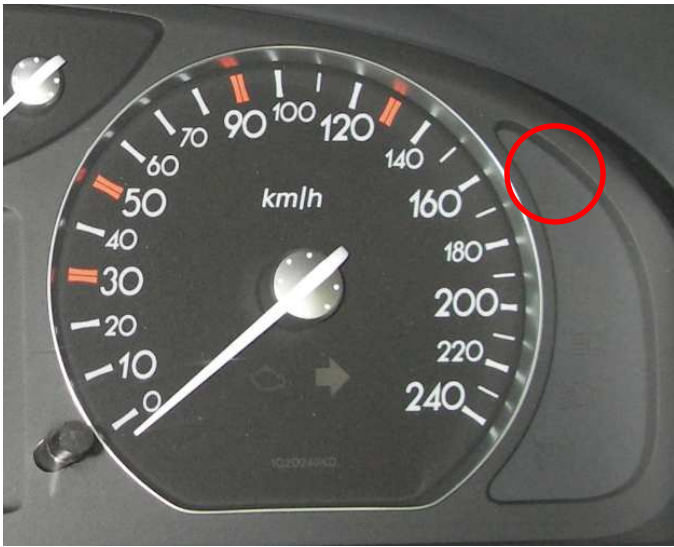
Fig. 1

If there are complaints about the above-mentioned fault, the cause could be water entry into a plug. The warning lamp for the headlight washer fluid minimum level is integrated into the instrument panel and is operative (top right of the display, see Fig. 1) even if the system is not fitted to the vehicle.

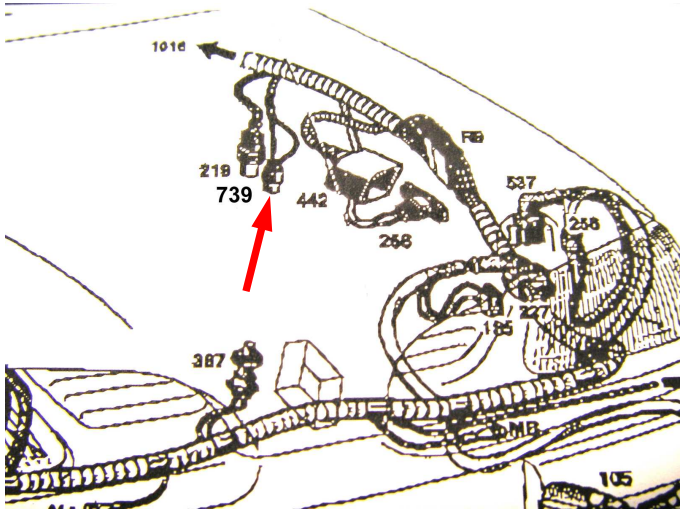
Fig. 2

Nevertheless, the plug for the fluid-level sensor is located above the front left wheel housing. Without a cover, the formation of corrosion in the plug arises due to moisture penetration. In this case, proceed as follows:

- Remove the trim from the front left kick panel.
- Check the condition of plug 739 (see Fig. 2).
- If the corrosion is light, the plug should be cleaned and then wrapped with insulating tape.
- In the event of heavy corrosion, the plug must be cut off and the individual cable ends insulated. After this, fasten both cables to the main cable loom with the aid of a cable clip.
- Refit removed parts in reverse order.
