## **Renault Twingo (X06) From model year 09.1998**

### **Airbag lamp illuminates**

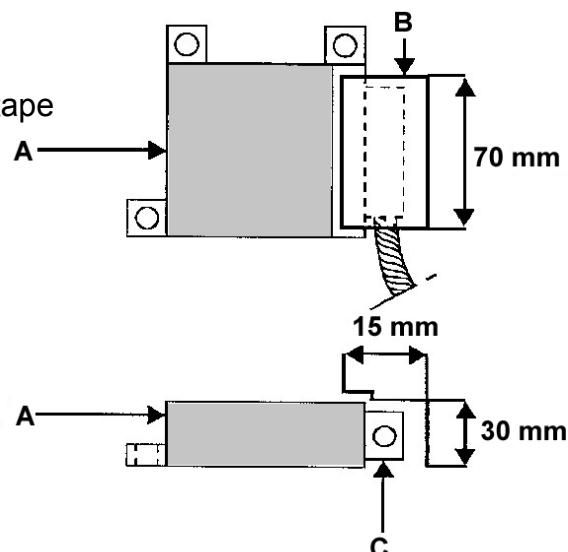
If there are complaints about the above-mentioned fault, the cause could be the airbag control unit. The above mentioned fault may occur due to the sensitivity of the control unit to electromagnetic influences. Therefore, the first thing to do is to ask the customer whether he or she was using a mobile telephone in the car when the control lamp illuminated. If the customer confirms this, the part number of the airbag control unit should be checked. A readout of this can be taken with the aid of a diagnosis tester. If the following part numbers are displayed:

a special copper adhesive tape must be wrapped around the plug-connection on the airbag control unit. This can be obtained via the vehicle manufacturer. The control unit is located under the panelling of the centre console (in front of the gear lever).
