Rover 75

ABS warning light comes on

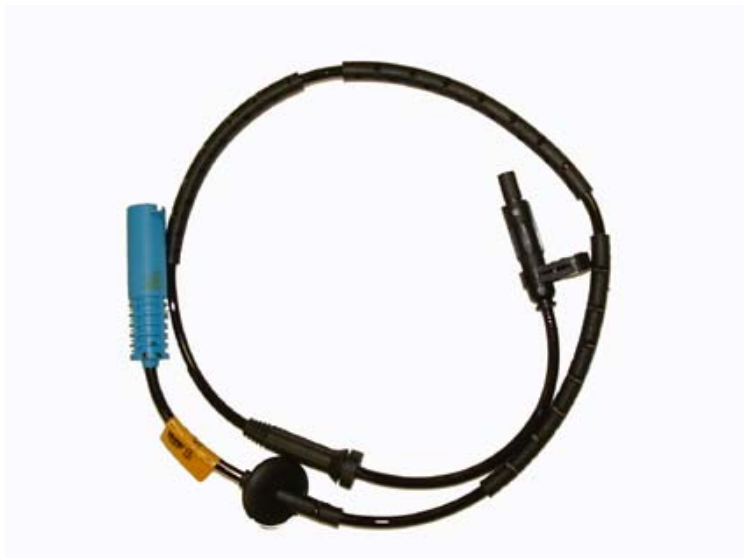
In the case of the above-mentioned vehicles, the ABS warning light can remain on permanently after the engine has been started up. This problem particularly affects vehicles up to chassis no.: RJ 138975. In many cases the fault is caused by water penetrating the ABS control unit.

The capillary affect makes humidity rise through the harness of the front ABS sensors to the ABS unit. To remedy the problem, the connection of the ABS unit and the sensors should be checked for humidity. The front ABS sensors (photo) must be replaced if necessary. Suitable sensors can be found in the Hella electronics range (part no.: 6PU 009 106-351).
