## **Saab 9-5** **All vehicles up to chassis no.:** **W3053331**

### **Damaged cables near the radio shaft.**

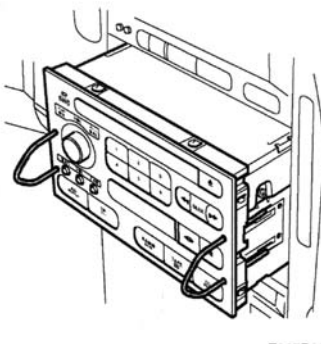
Fig. 1

With these vehicles it is possible that a cable strand is damaged in the rear part of the radio shaft. The cable strand has been laid too near to the lower right-hand corner of the radio shaft. To prevent or eliminate damage, proceed as follows:

- Note radio code.
- Pull the radio out of the shaft (Fig. 1).
- Remove the radio shaft from the central console and loosen the plug connections (Fig. 2).
- Check whether the cable strand on the right-hand side of the shaft is damaged.
- Repair the damaged cable.
- Change the position of the cable strand in such a way that contact with the radio shaft is no longer possible.
- Reinstall the components in reverse order.
